INDOOR AIR QUALITY ASSESSMENT

**Southeast Middle School
95 Viscoloid Avenue
Leominster, MA 01453**

Prepared by:
Massachusetts Department of Public Health
Center for Environmental Health
Emergency Response Indoor Air Quality Program
October 2005

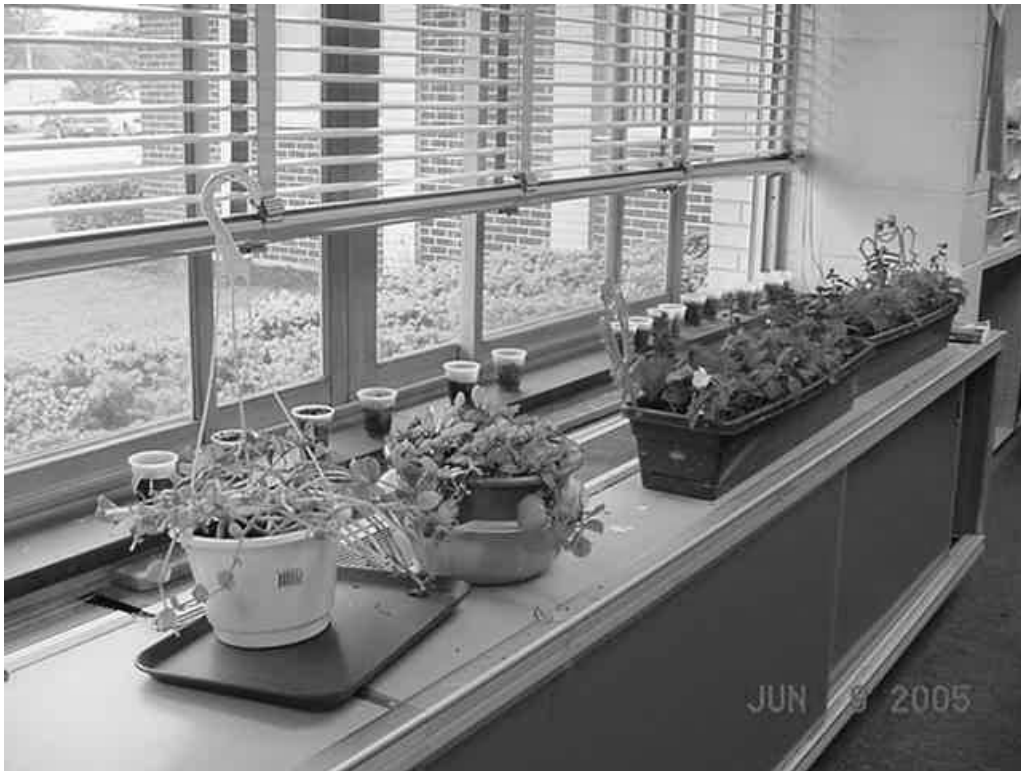
Picture 1

Fresh air in classrooms in the main building is supplied by unit ventilator (univent) systems (Pictures 1 and 2) equipped with high efficiency pleated filters (Picture 3). Filters are reportedly changed during each school vacation. Each filter is dated for the date change. Of the univent filters examined, some filters were not dated, and one was dated for February 2005 (the last school vacation was April 2005) (Picture 3).

Plants were noted in several classrooms, and flowering plants were seen in close proximity to univent air intakes (Pictures 1 and 13). Plants can be a source of pollen and mold, which can be respiratory irritants for some individuals. Plants should be properly maintained and equipped with drip pans. Plants should also be located away from ventilation sources (e.g., air intakes, univent diffusers) to prevent the entrainment and/or aerosolization of dirt, pollen or mold.

Classroom Univent, Note Plants on Unit

11. Clear plant growth and other materials/debris away from the proximity of univent air intakes.
12. Examine plants in classrooms for mold growth in water catch basins. Disinfect water catch basins if necessary. Remove plants from ventilation sources and/or carpeted areas.

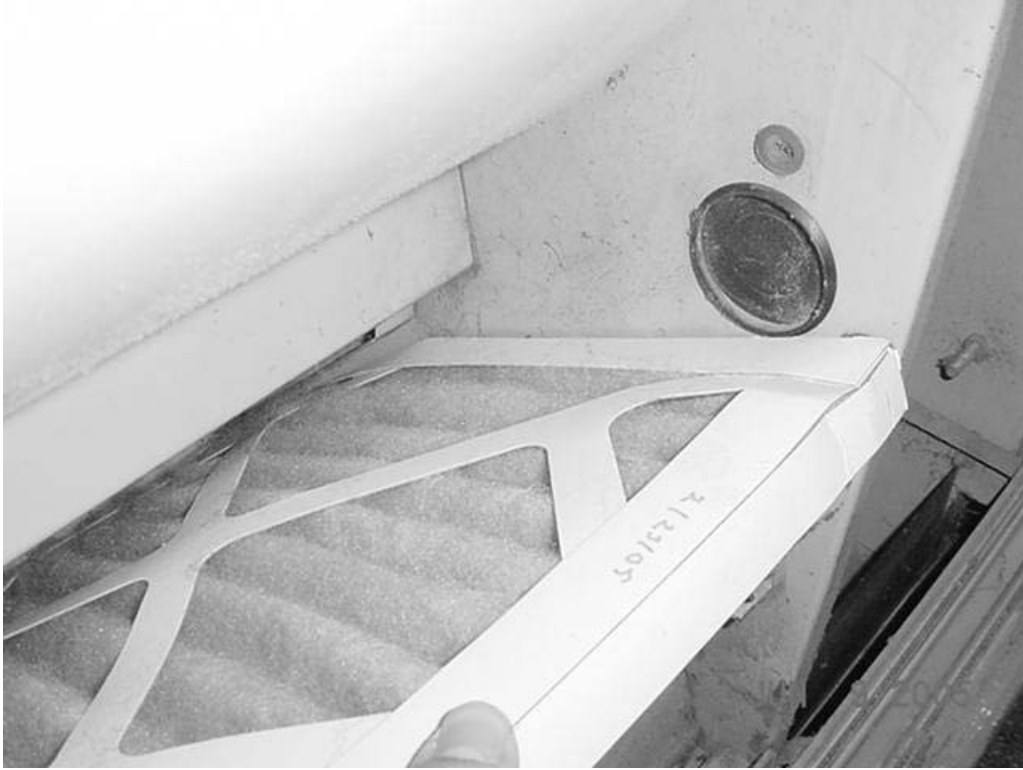
Picture 3

High-Efficiency Pleated Air Filters in Univent

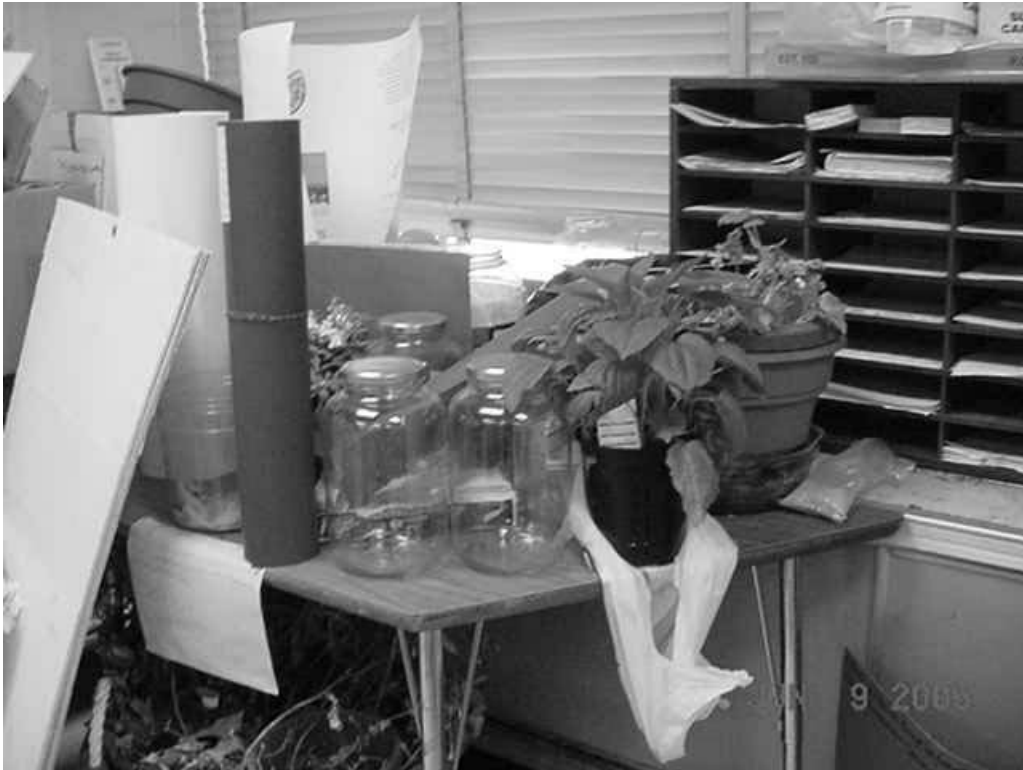
Picture 5

found deactivated during the assessment (Table 1). Obstructions to airflow, such as papers and books stored on univents and bookcases, carts and desks in front of univent returns, were seen in several classrooms (Picture 5). In order for univents to provide fresh air as designed, units must be activated and remain free of obstructions. Mechanical exhaust ventilation for classrooms in the main building is provided by wall-mounted vents powered by rooftop motors (Pictures 6 and 7). These vents were operating in all classrooms surveyed. However, a number of exhaust vents were obstructed by various classroom items impeding airflow (Picture 6).

Univent Obstructed by Various Items

4. Remove all obstructions from univents and exhaust vents to facilitate airflow. Close classroom doors to improve air exchange.
5. Set thermostats for modular classrooms to the fan “on” setting to provide continuous air exchange.

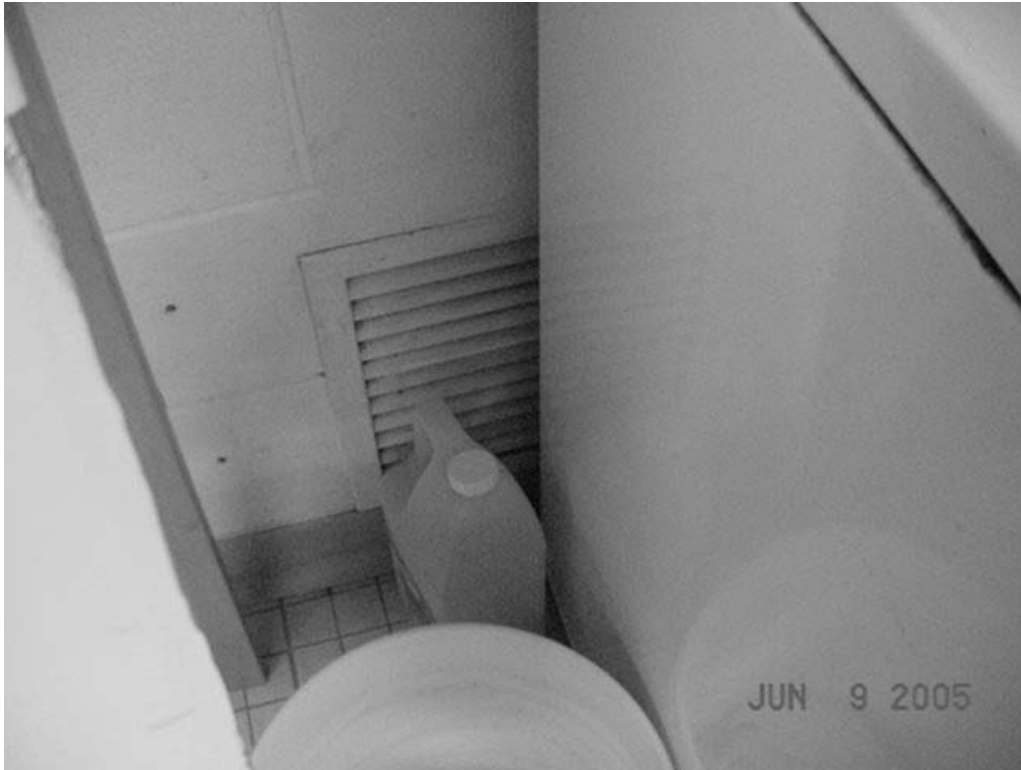
Picture 6

Obstructed Wall-Mounted Exhaust Vent in Classroom

2. Examine exhaust vents for function and make repairs as necessary.
3. Operate all ventilation systems that are operable throughout the building (e.g., gym, auditorium, classrooms) continuously during periods of school occupancy independent of thermostat control to maximize air exchange.

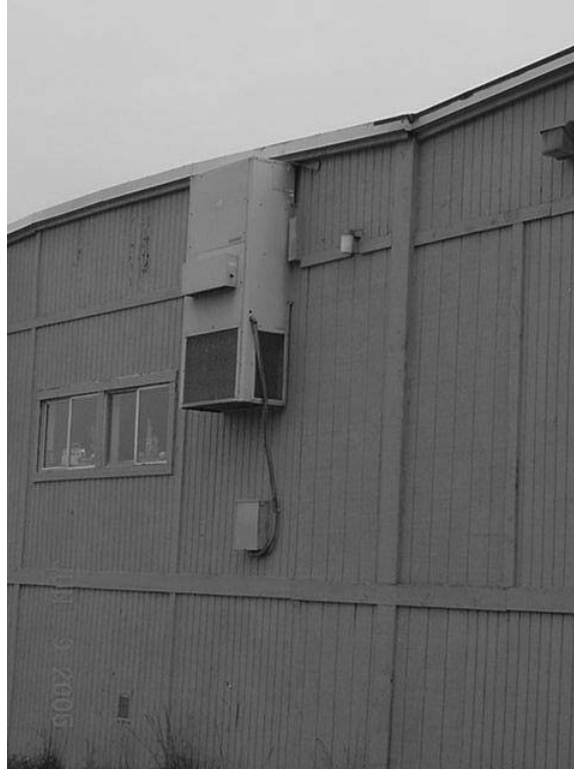
Picture 8

Ventilation for modular classrooms is provided by AHUs mounted on the exterior wall of the building (Picture 8). Fresh air is distributed to classrooms via ductwork connected to ceiling-mounted air diffusers (Picture 9) and drawn back to the units through wall-mounted grilles (Picture 10). Thermostats control each heating, ventilating and air conditioning (HVAC) system and have fan settings of “on” and “automatic”. Thermostats were set to the “automatic” setting during the assessment. The automatic setting on the thermostat activates the HVAC system at a preset temperature. Once the preset temperature is reached, the HVAC system is deactivated. Therefore, no mechanical ventilation is provided until the thermostat re-activates the system. It is also important to note that classrooms are equipped to provide chilled air in warm weather, which limits outside air intake on hot, humid days (as was the case during the assessment). Limiting outside air intake can contribute to an increase in carbon dioxide levels.

Modular Air Handling Unit

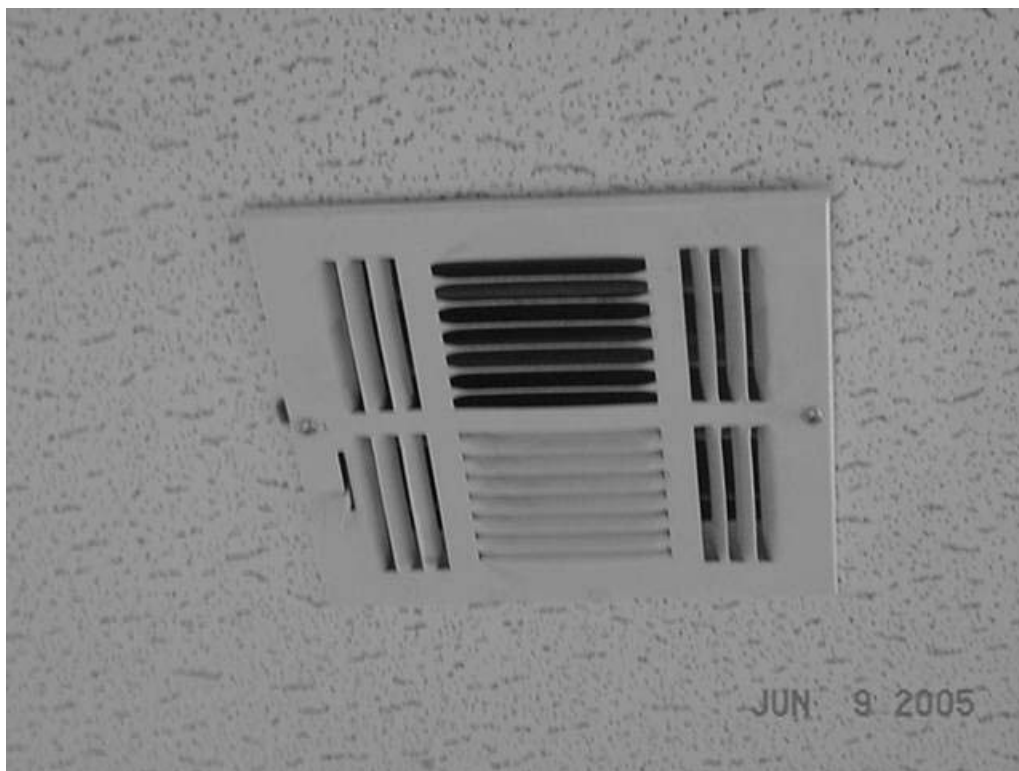
Picture 9

Ceiling-Mounted Air Diffuser for Modular Classroom

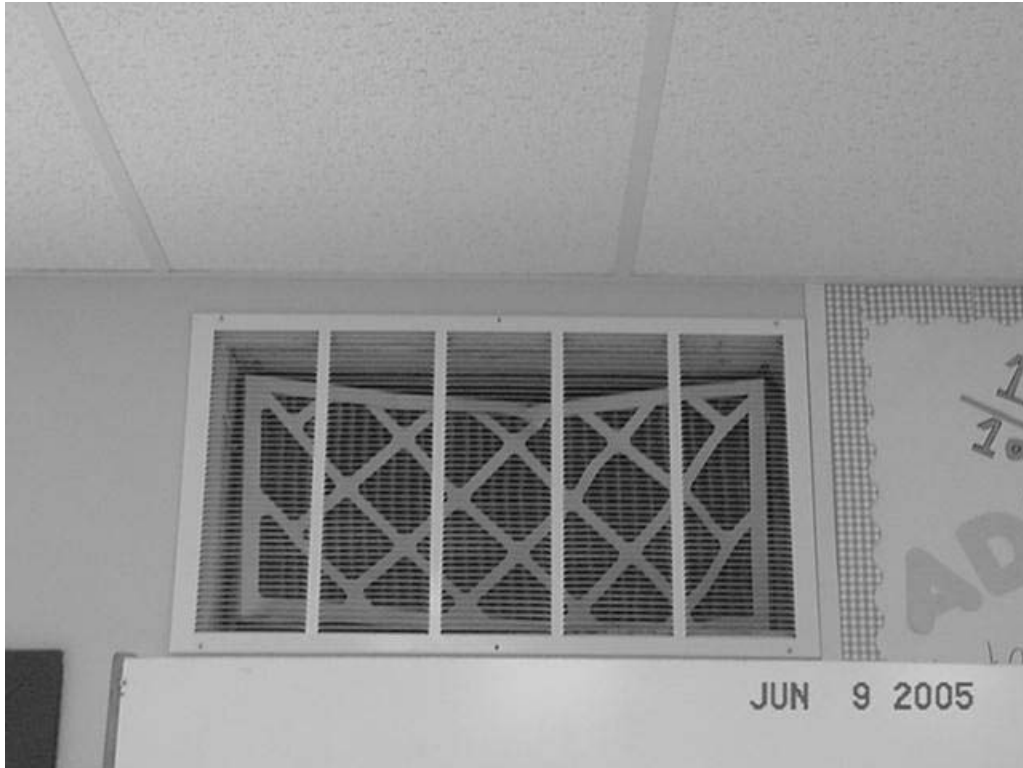
Picture 10

Return Vent for Modular Air Handling Unit

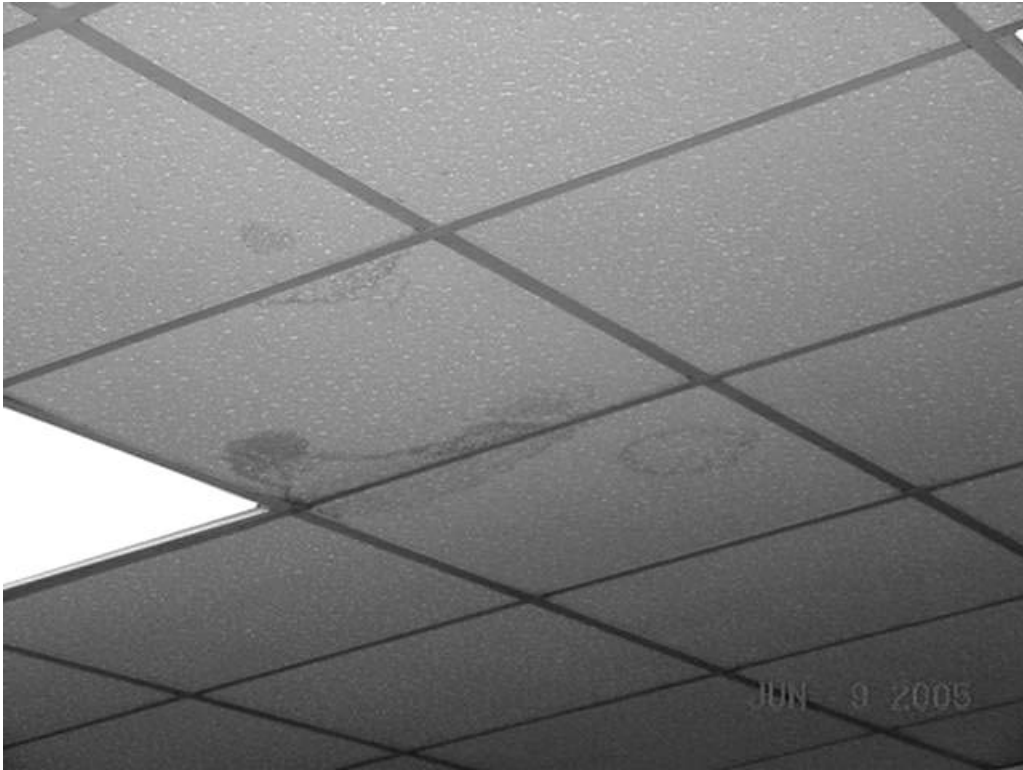
Picture 11

Several areas had water-stained ceiling tiles, which can indicate leaks from the roof or plumbing system (Picture 11). Water-damaged ceiling tiles can provide a source for mold and should be replaced after a water leak is discovered and repaired. Open seams between the sink countertop and backsplash were observed in several rooms (Picture 12). If not watertight, water can penetrate through the seam, causing water damage. Water penetration and chronic exposure of porous and wood-based materials can cause these materials to swell and show signs of water damage.

Water Damaged Ceiling Tiles

8. Ensure roof and/or plumbing leaks are repaired, and replace/repair water damaged building materials. Examine the area above and around these areas for mold growth. Disinfect areas of water leaks with an appropriate antimicrobial.

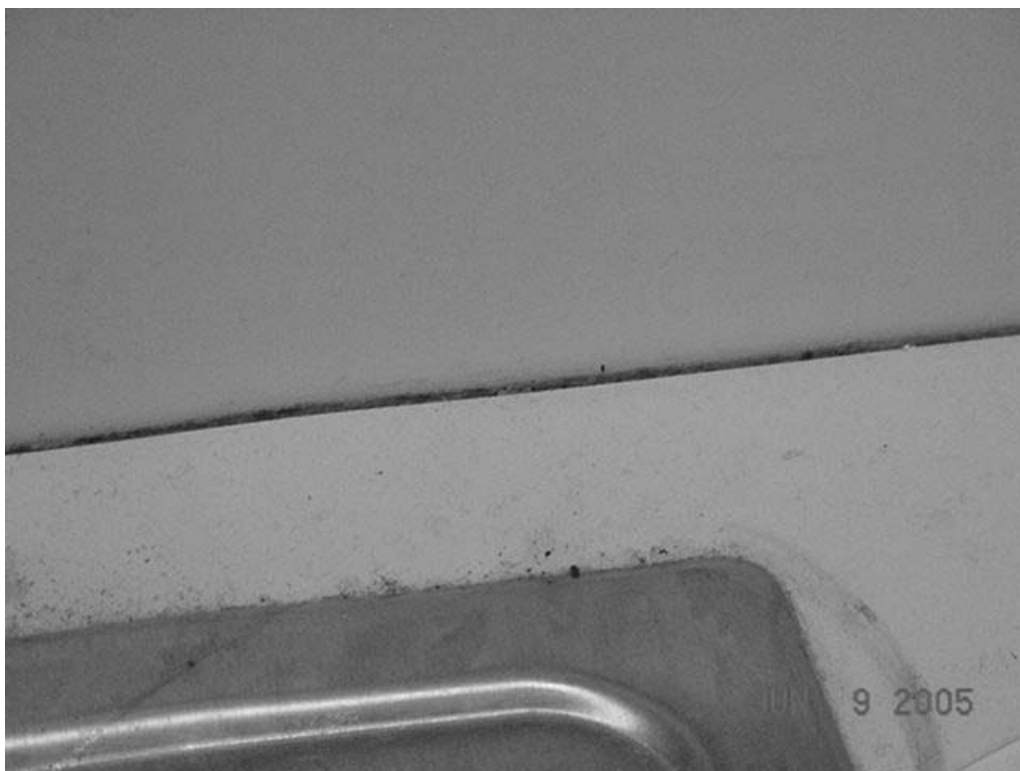
Picture 12

Space Between Classroom Sink and Backsplash

13. Clean and maintain aquariums and terrariums to prevent bacterial/microbial growth and associated odors.
14. Seal seams between sink countertops and backsplash to prevent water damage and/or microbial growth.

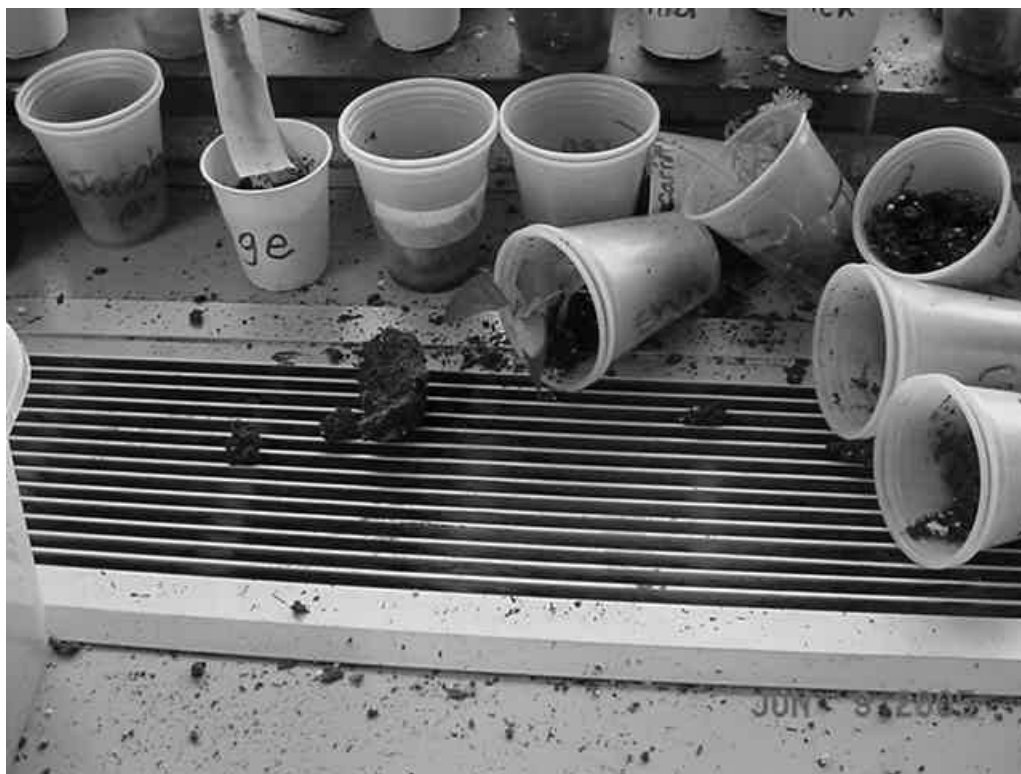
Picture 13

Plants and Potting Soil on Fresh Air Diffuser

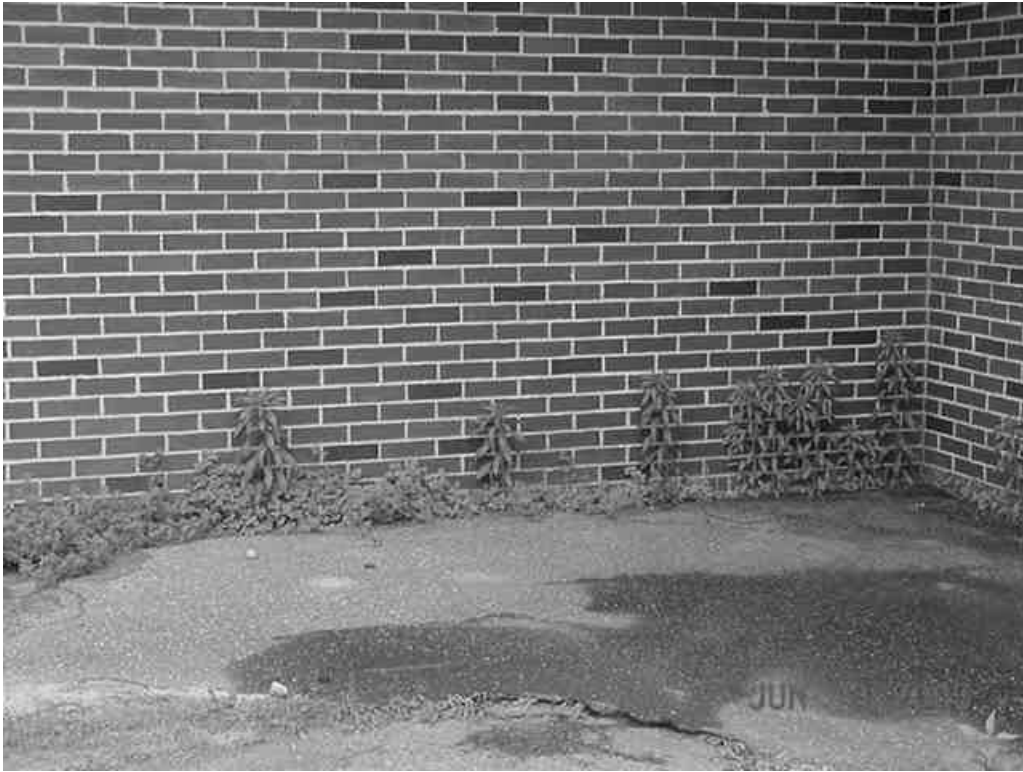
Picture 14

Plants were observed to be growing against exterior walls (Picture 14). The growth of roots against exterior walls can bring moisture in contact with the foundation. Plant roots can eventually penetrate, leading to cracks and/or fissures in the sublevel foundation. Over time, this process can undermine the integrity of the building envelope, providing a means of water entry into the building via capillary action through foundation concrete and masonry (Lstiburek & Brennan, 2001).

Plants Growing between Tarmac and Exterior Walls

9. Replace missing downspout. Examine gutter/downspout system periodically to ensure gutters are free of debris, and downspouts are intact.
10. Remove plants growing against building and its foundation to prevent water intrusion through brickwork.

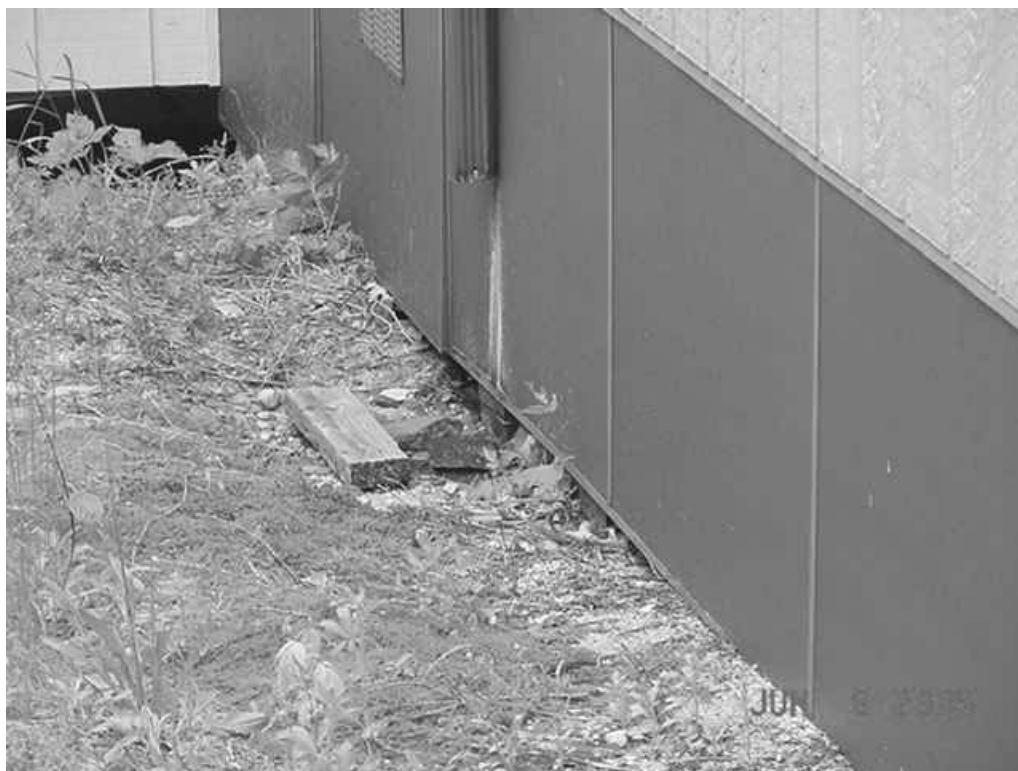
Picture 15

MDPH staff examined the building exterior and observed several downspouts missing from the drainage/gutter system (Picture 15). Sections of the exterior walls appeared to be saturated with moisture. Excessive exposure of exterior brickwork to water can result in damage over time.

Missing Downspout/Elbow

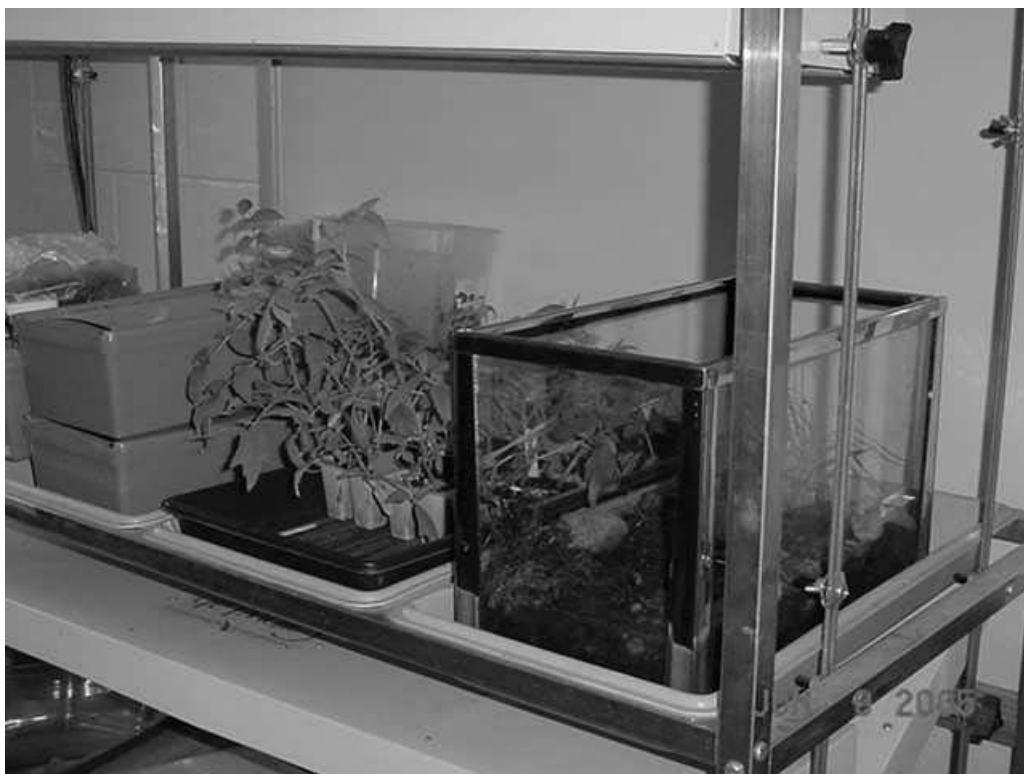
Picture 16

Several classrooms contained aquariums and terrariums (Picture 16). Aquariums should be properly maintained to prevent microbial/algae growth, which can emit unpleasant odors. Similarly, terrariums should be properly maintained to ensure soil does not become a source for mold growth.

Terrarium and Plants in Classroom

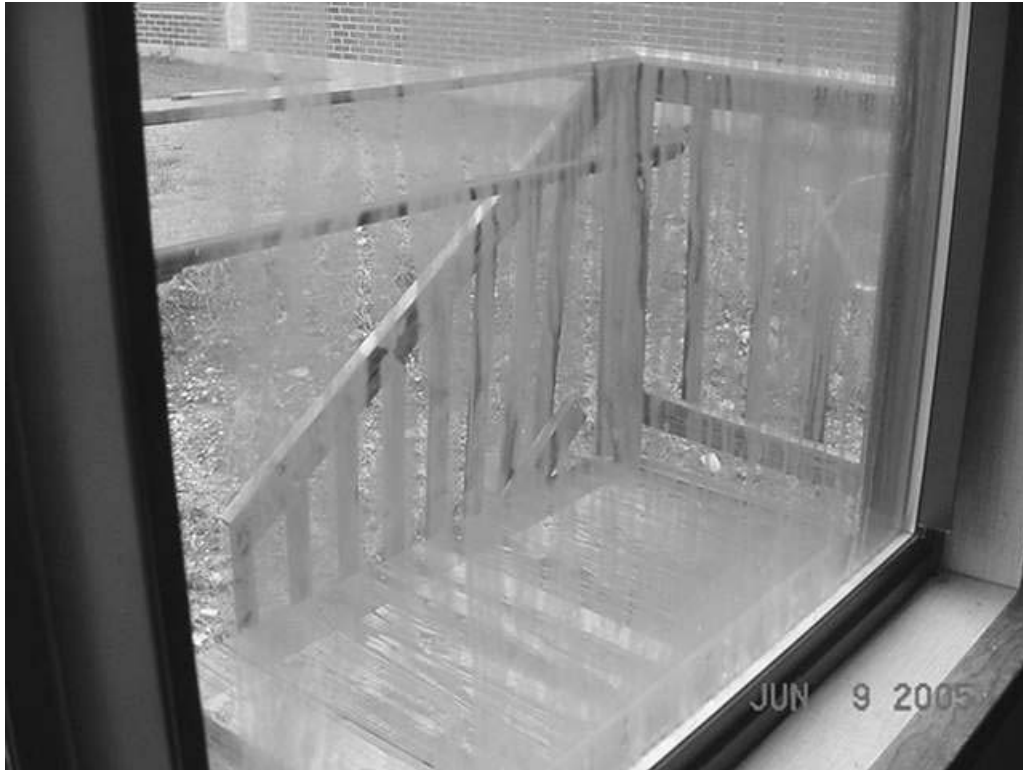
Picture 17

As discussed, the air-conditioning in the modular building was operating with windows and exterior doors open. As a result, condensation was observed on a number of windows (Picture 17). Over time, chronic condensation can result in damage to the building materials.

Condensation on Windows in Modular Classroom

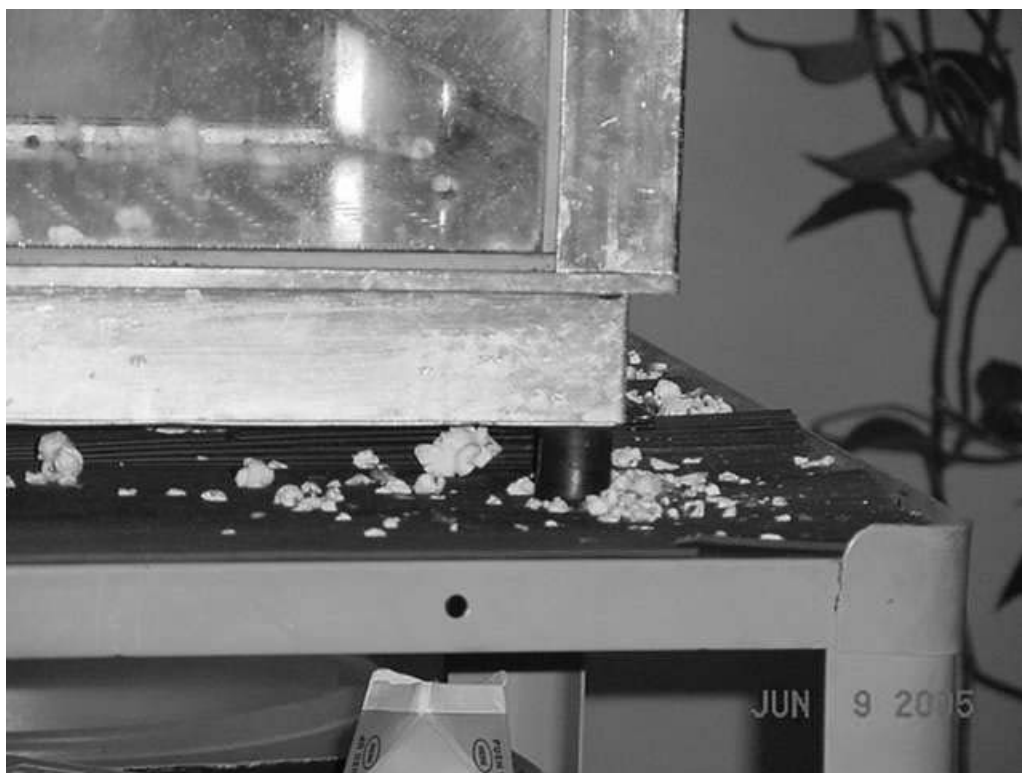
Picture 18

Several other conditions that can potentially affect indoor air quality were identified. Pest attractants were identified within the building. A popcorn machine (Picture 17), food-based projects and re-use of food containers were observed. Proper food storage is an integral component in maintaining indoor air quality. Food should be properly stored and clearly labeled. Reuse of food containers is not recommended since food residue adhering to the surface may serve to attract pests.

Popcorn Machine

15. Store and label food appropriately. Refrain from re-using food and/or containers as project materials to prevent pest attraction.
16. Relocate or consider reducing the amount of materials stored in classrooms to allow for more thorough cleaning. Clean items regularly with a wet cloth or sponge to prevent excessive dust build-up.

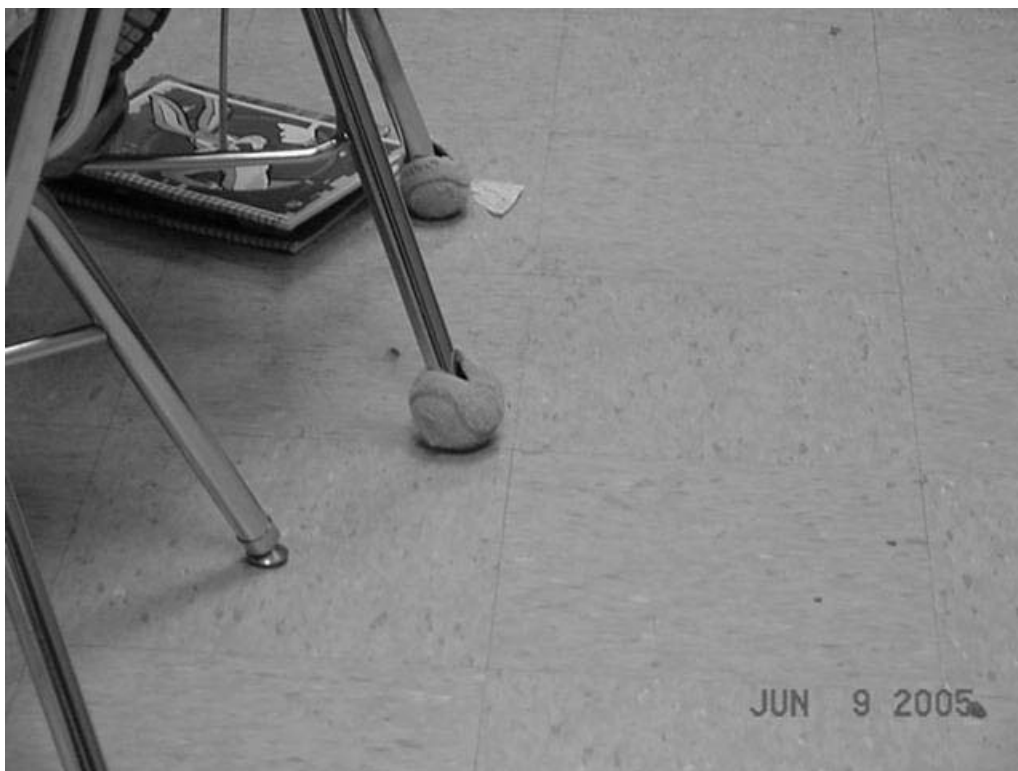
Picture 19

In an effort to reduce noise from sliding chairs, tennis balls had been cut open and placed on chair legs (Picture 19). Tennis balls are made of a number of materials that are a source of

respiratory irritants. Constant wearing of tennis balls can produce fibers and cause off-gassing of VOCs. Tennis balls are made with a natural rubber latex bladder, which becomes abraded when used as a chair leg pad. Use of tennis balls in this manner may introduce latex dust into the school environment. Some individuals are highly allergic to latex (e.g., spina bifida patients) (SBAA, 2001). It is recommended that the use of materials containing latex be limited in buildings to reduce the likelihood of symptoms in sensitive individuals (NIOSH, 1997). A question and answer sheet concerning latex allergy is attached as [Appendix C](#) (NIOSH, 1998). Consider replacing tennis balls with alternative glides (Picture 20).

Tennis Ball on Chair Leg

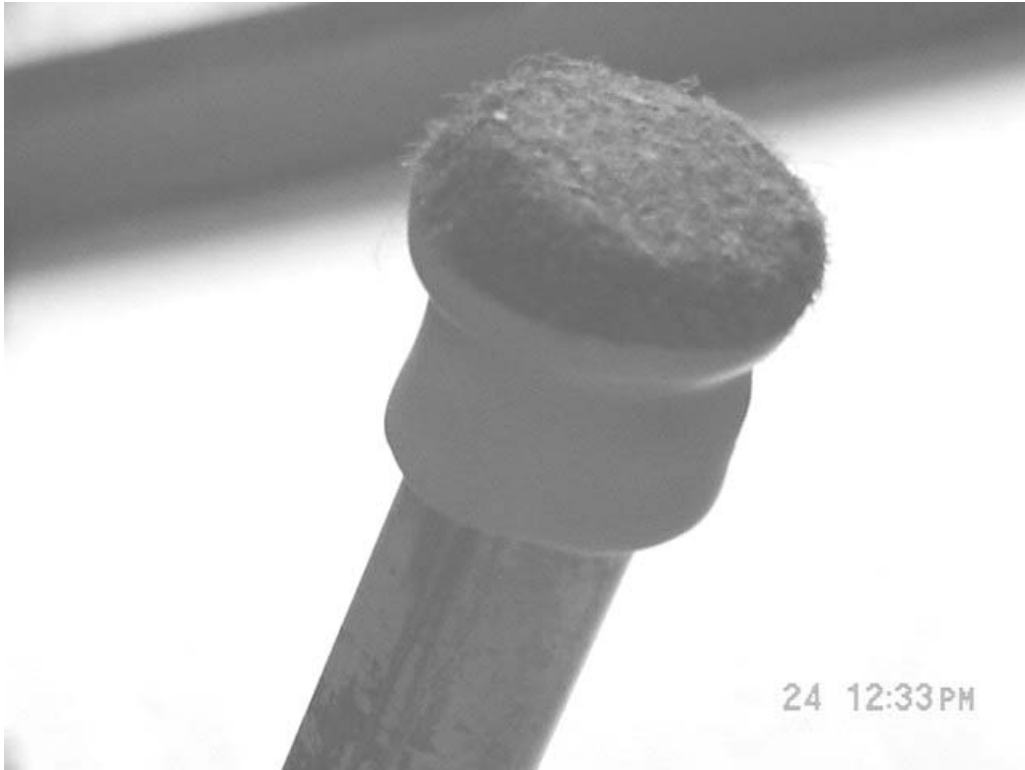
Picture 20

“Glides” for Chair Legs that can be used as an Alternative to Tennis Balls
